A MULTIDISCIPLINARY ENGINEERING  
GEOLOGICAL INVESTIGATION OF CLIFF  
COLLAPSE AT REDCLIFFS IN THE  
22 FEBRUARY AND 13 JUNE 2011  
EARTHQUAKES

A thesis

**Master of Science in Engineering Geology**

2013

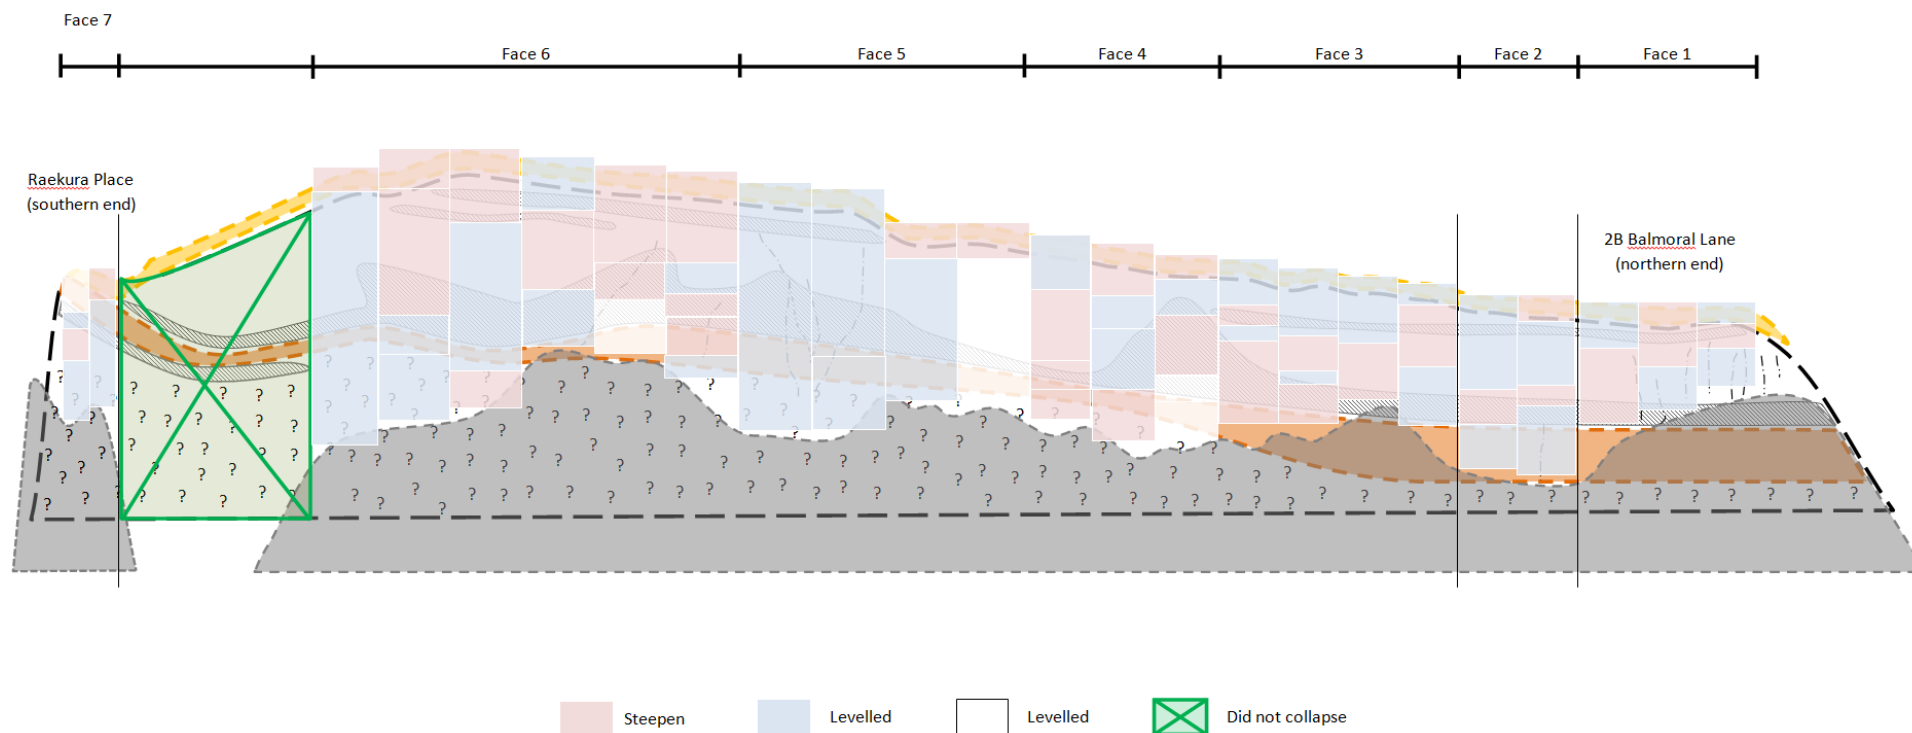
Figure 61 - The resulting different in slope gradients after the first collapse in February 2011, based on overlapping the slope gradient measurements Figure 44 and 45.

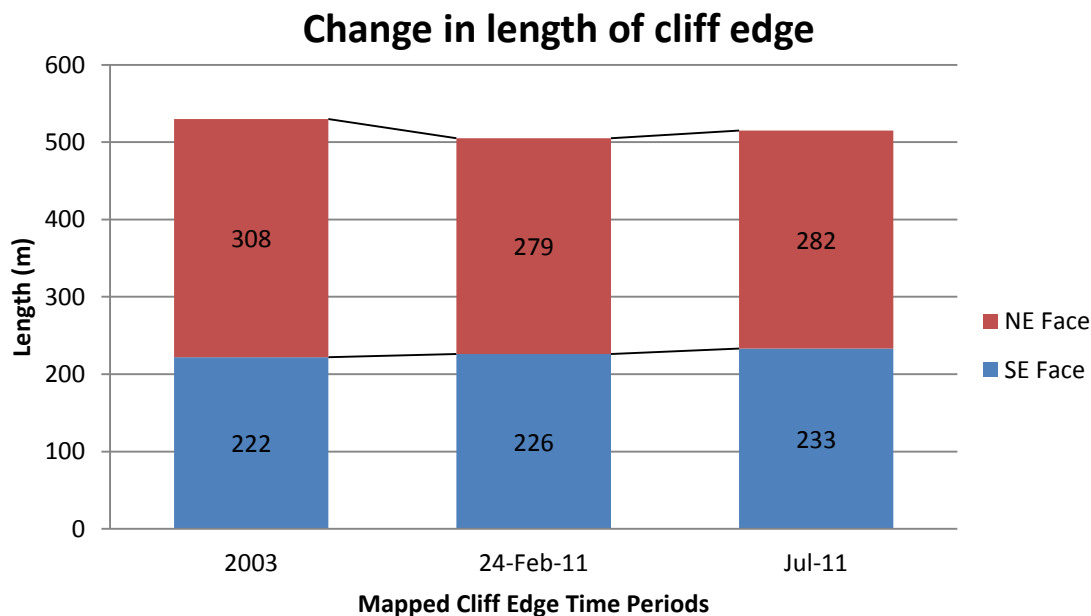
Figure 62 - Length of the cliff edge before and after the February 22 and June 13 2011 earthquakes.

The results show an overall shortening of the cliff edge after the first collapse, with some lengthening occurring after the second cliff collapsing incident. This suggests that the first collapse decreased the waviness of the cliff edge which may be the result of a more uniform collapse of the cliff overall; whereas the second collapse was more concentrated in certain sections along the cliff edge, which increased the waviness of the cliff edge once again. While the NE Face follows the same pattern, the SE face has steadily increase in length which suggest an increase in waviness of the cliff edge on account of more localised collapsed of the cliff (including the cliff top) after each earthquake.

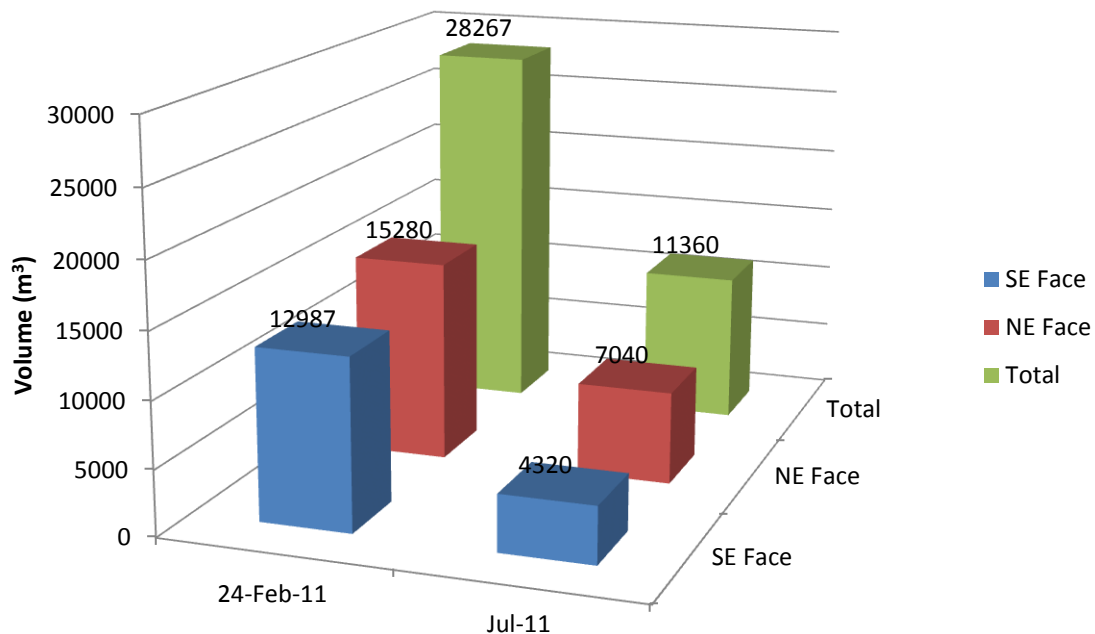
Figure 63 - Estimation of the volume of material which came down from the Redcliffs cliff as a result of the February and June 2011 earthquake. The dates used correspond to when the measurements were taken needed to make the calculation possible, thus representing the volume of material the cliff loss up till that specific point in time.

The results presented in Figure 63 reflect the variables for the base area used, whereby a greater volume of material from the cliff face had fallen as a result of the earthquake on February 22 2011 in comparison to the June 13 2011 earthquake. This subsequent decrease in volume of rock and soil material falling from the cliff face after the June 2011 is due to the removal of most of the already weakened / eroded rock and soil from the cliff face (including the seismically weakened material) as a result of the February earthquake. On the other hand, the rock and soil which came down from Redcliffs because of the June 13 2011 quake are likely to be only seismically weakened material triggered by the February and June earthquakes.

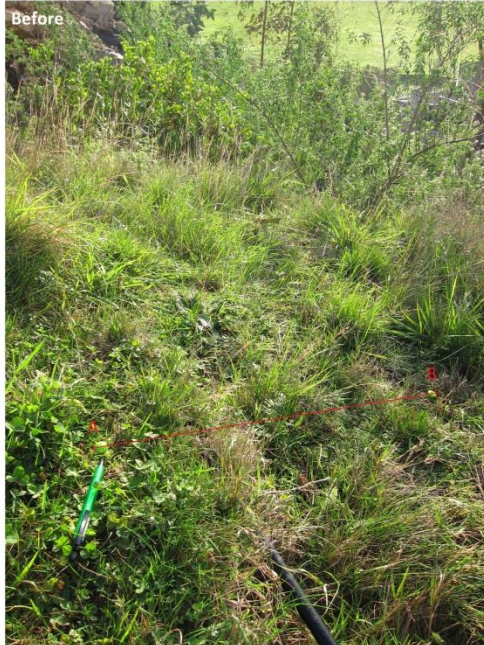
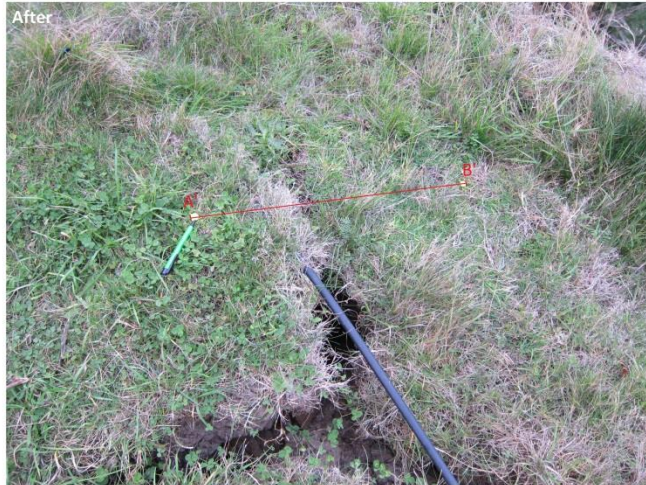
Site 1

$A - B = 620 \text{ mm (13/6/2011)}$

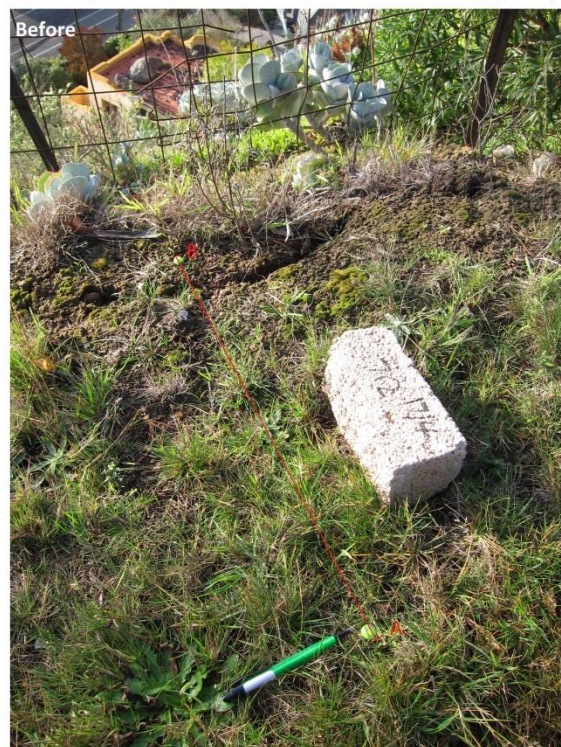
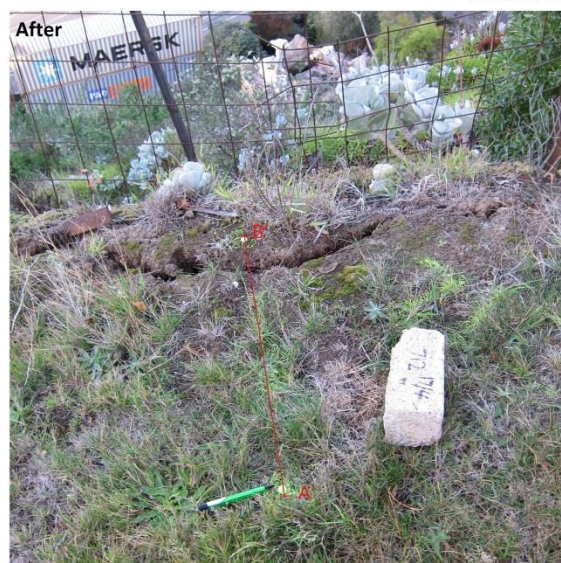
Site 2

$A - B = 712 \text{ mm (13/6/2011)}$

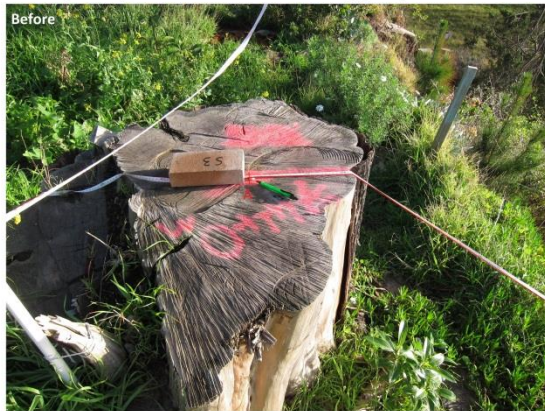
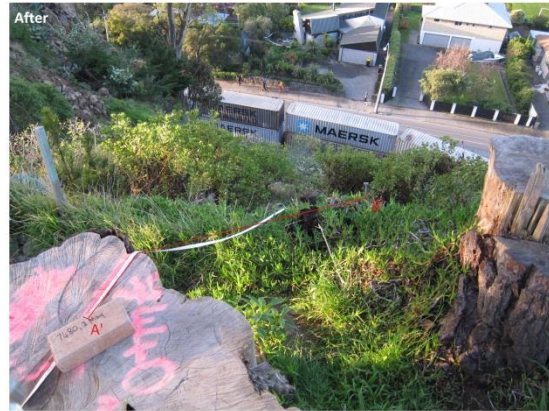
#### Site 3

$A - B = 7480 \text{ mm}$  (13/6/2011)

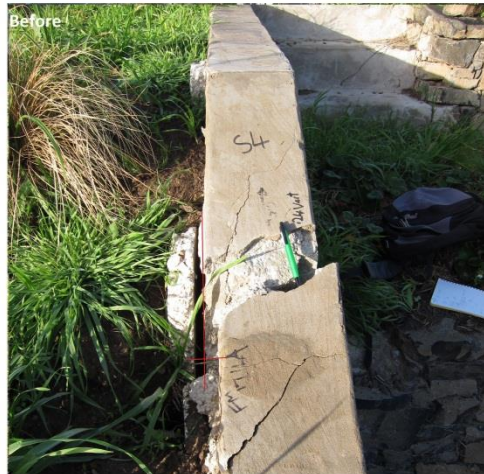
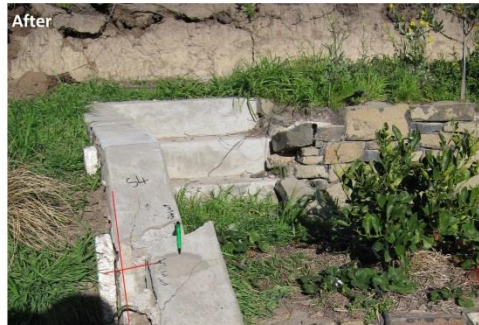
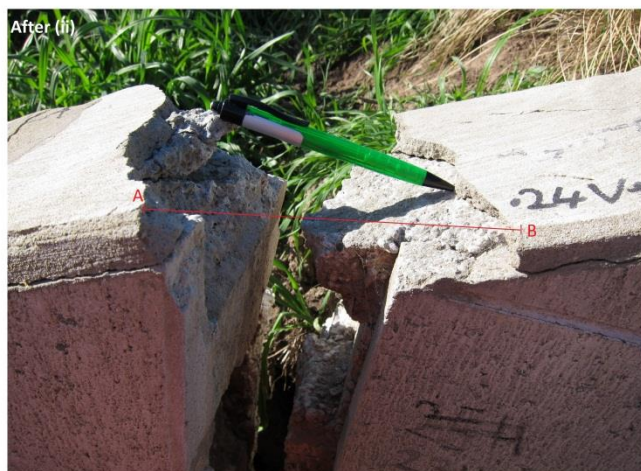
#### Site 4

No accurate measurements can be made due to the lack of a reference. However, it can be seen that a clear vertical and horizontal displacement occurred on the retaining wall after the 13/6/2011 quake.

$A - B = 647 \text{ mm}$  (17/6/2011)

Note, the measurement taken included a vertical component, as it was done on an angle.

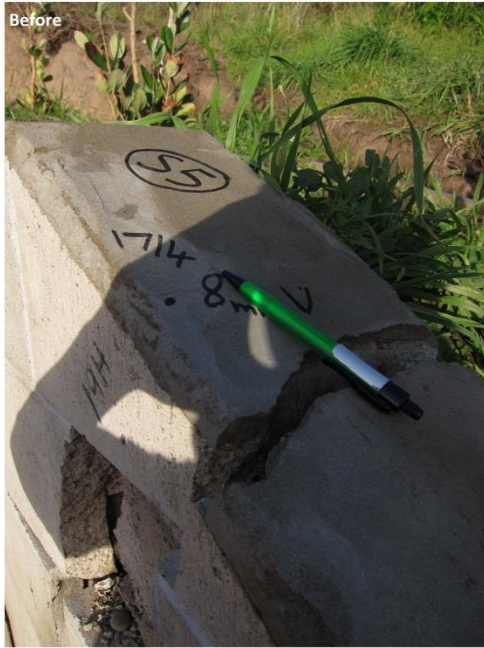
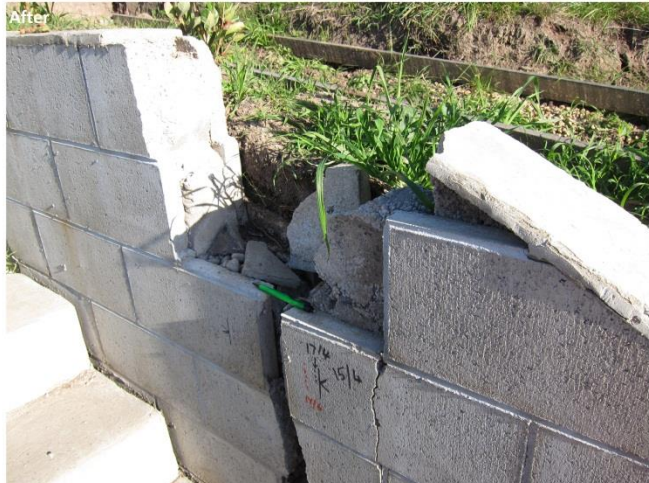
Site 5

$15/4$  (point of arrowhead) –  $17/4 = 5 \text{ mm}$  (17/4/2011)

$15/4$  (point of arrowhead) –  $14/6 = 19 \text{ mm}$  (14/6/2011)

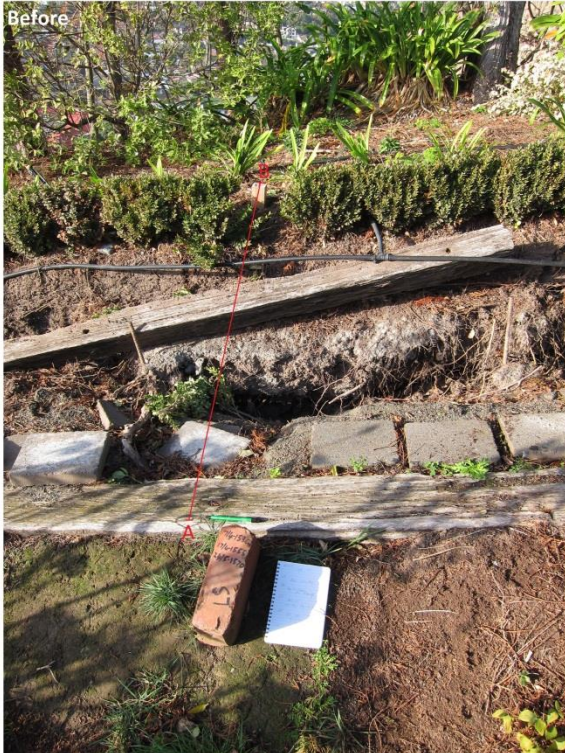
Site 6

A revisit after 13/6/2011 was not possible as all possible entrances were blocked off by falling debris and was decided too risky to attempt an access.

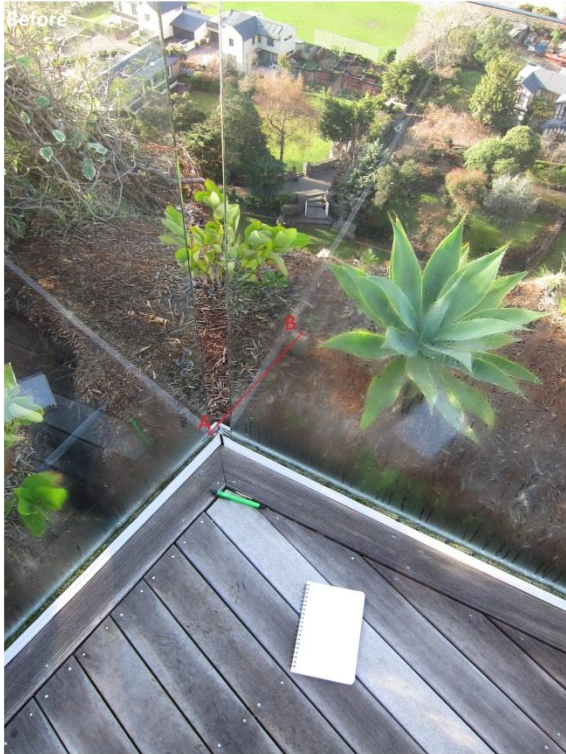
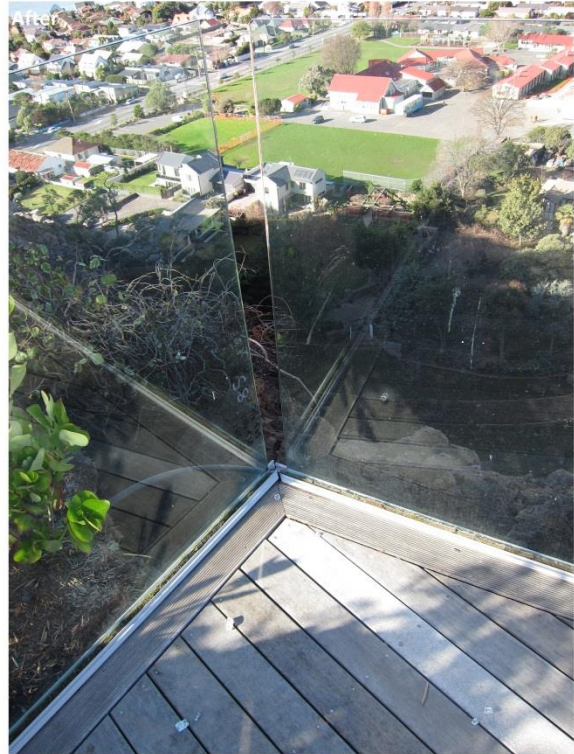
Site 7

Since the quake on 13/6/2011, it is evident that part of the site has collapsed and no further measurements could be made.

A – B = 580 mm (13/6/2011)

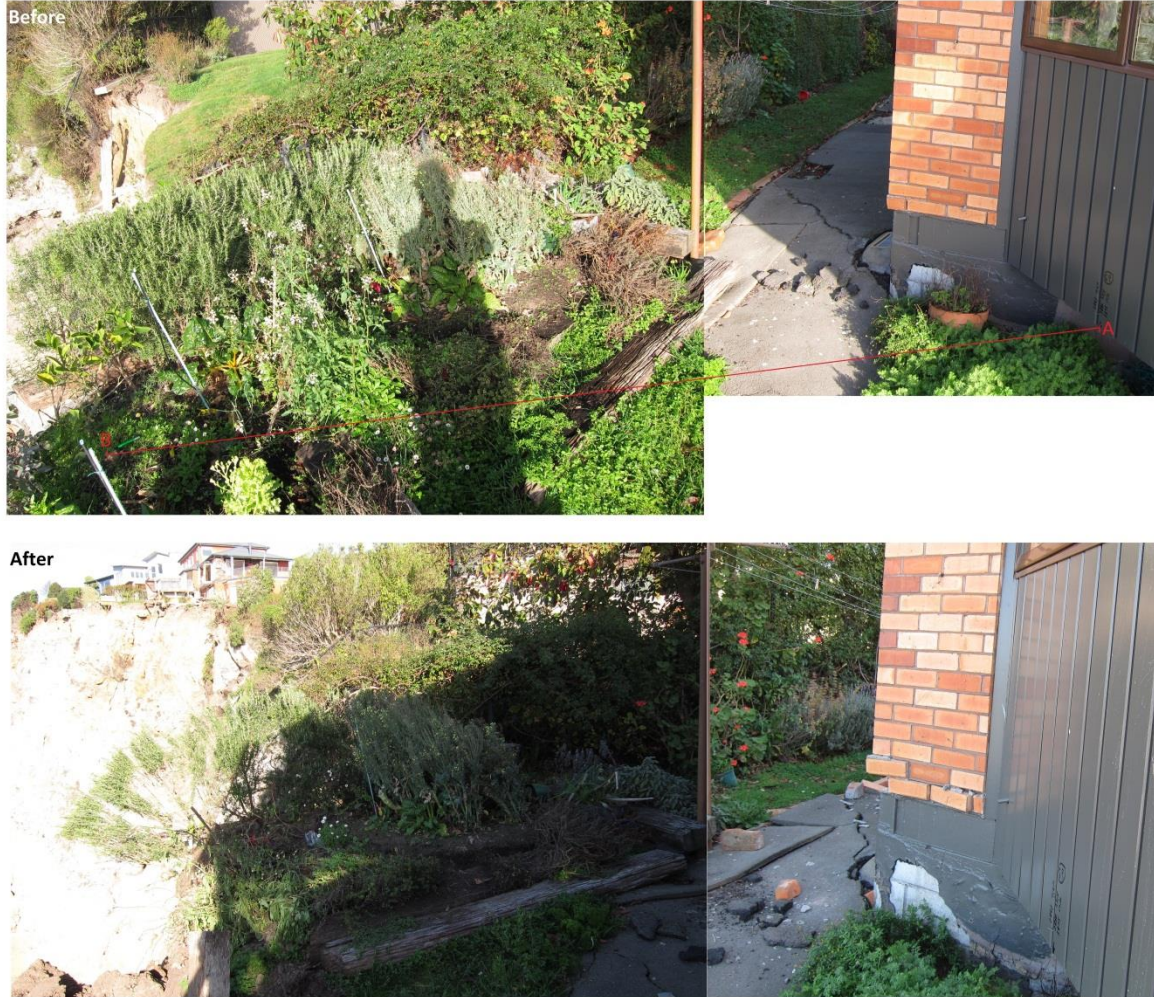
Site 8

Another site which collapsed after the 13/6/2011 quake which made it impossible to take any more measurements.

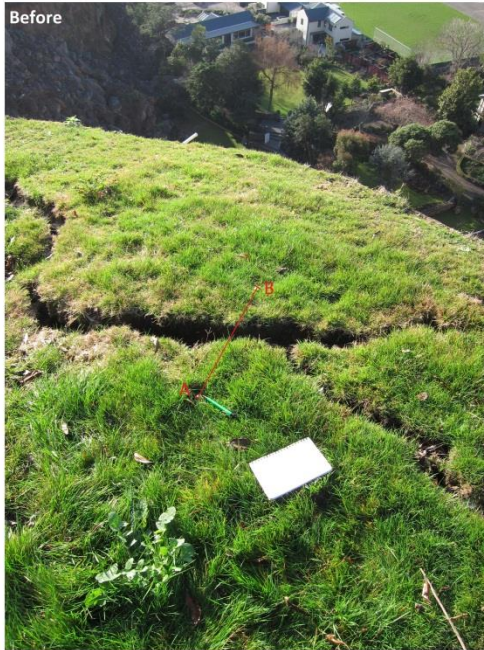
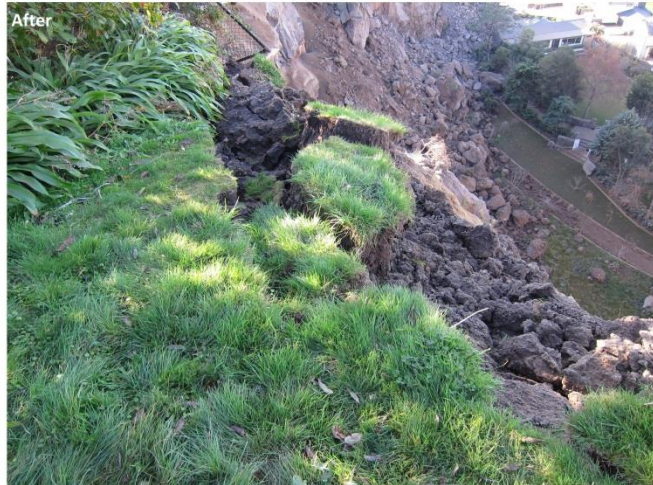
Site 10

Another site unable to continue measuring as part of the site has collapsed.

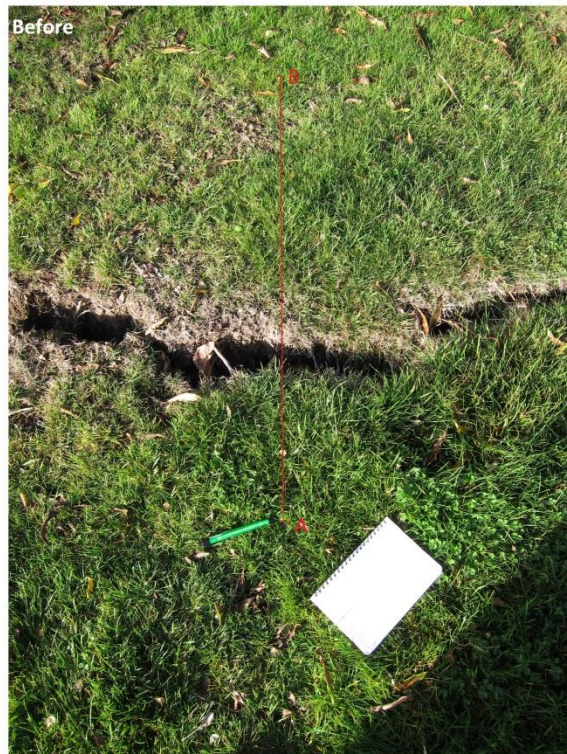
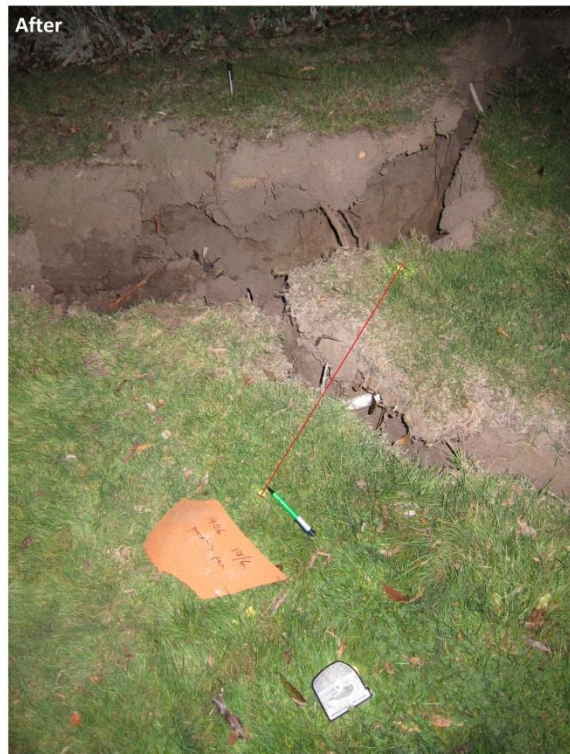
Site 11

A - B = 621 mm (13/6/2011)

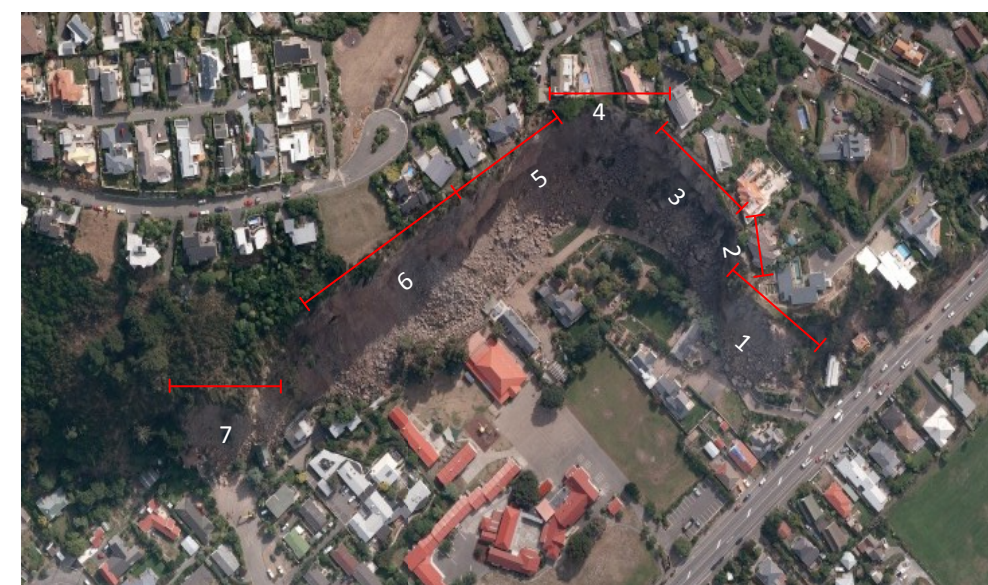
### (Map 2)

This map is a general representation of the volcanic deposits and structural condition of the cliff face. Mapping was carried out following the 13 June 2011 earthquakes, but before the 23rd December 2011 earthquakes.
